Cyclic Corrosion and Chlorination of an FeCrAl Alloy in the Presence of KCl

Israelsson, N., Unocic, K., Hellström, K. et al (2015). Cyclic Corrosion and Chlorination of an FeCrAl Alloy in the Presence of KCl. *Oxidation of Metals*, 84(3-4): 269-290.
<http://dx.doi.org/10.1007/s11085-015-9554-3>

Abstract The KCl-induced corrosion of the FeCrAl alloy Kanthal[®] APMT in an O₂ + N₂ + H₂O environment was studied at 600 °C. The samples were pre-oxidized prior to exposure in order to investigate the protective nature of alumina scales in the present environment. The microstructure and composition of the corroded surface was investigated in detail. Corrosion started at flaws in the pre-formed α -alumina scales, i.e. α -alumina was protective in itself. Consequently, KCl-induced corrosion started locally and, subsequently, spread laterally. An electrochemical mechanism is proposed here by which a transition metal chloride forms in the alloy and K₂CrO₄ forms at the scale/gas interface. Scale de-cohesion is attributed to the formation of a sub-scale transition metal chloride.

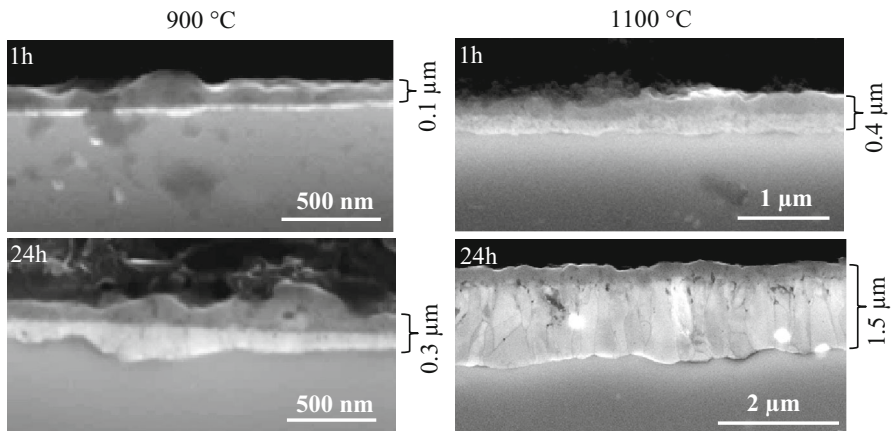
Fig. 1 SEM-SE micrographs of cross-sections of the pre-formed alumina scales in O_2 at 900 and 1,100 °C for 1 and 24 h, published in [18, 19] by Hellström et al

A well adherent alumina scale had formed after all pre-oxidation treatments, scale thickness ranging from 0.1 to $1.5\text{ }\mu\text{m}$ depending on oxidation time and temperature (Fig. 1). Both samples oxidized at $1,100\text{ }^{\circ}\text{C}$ and the sample oxidized for 24 h at $900\text{ }^{\circ}\text{C}$ clearly exhibited a two-layered oxide scale. The bottom scale

layer was barely visible after 1 h at 900 °C (Fig. 1). A TEM investigation by Hellström et al. confirmed the presence of a two-layered $\alpha\text{-Al}_2\text{O}_3$ scale after oxidation at 900 °C, the inward growing alumina layer was however not continuous over the entire surface [18]. Analysis using XRD showed that $\alpha\text{-Al}_2\text{O}_3$ was present on all pre-oxidized samples. There was no evidence of metastable forms of alumina.

This study investigated the ability of a pre-formed external alumina scale to prevent KCl-induced corrosion. The scale cross sections in Fig. 1 and the XRD analysis showed that all four pre-oxidations (1 and 24 h at 900 and 1,100 °C in $O_2 + N_2$) generated continuous α -alumina layers. The oxidation behaviour is in line with literature reports on the ability of alloy APMT and other FeCrAl alloys to form highly protective α -alumina scales in the presence of O_2 at 900 °C and higher [22–24].

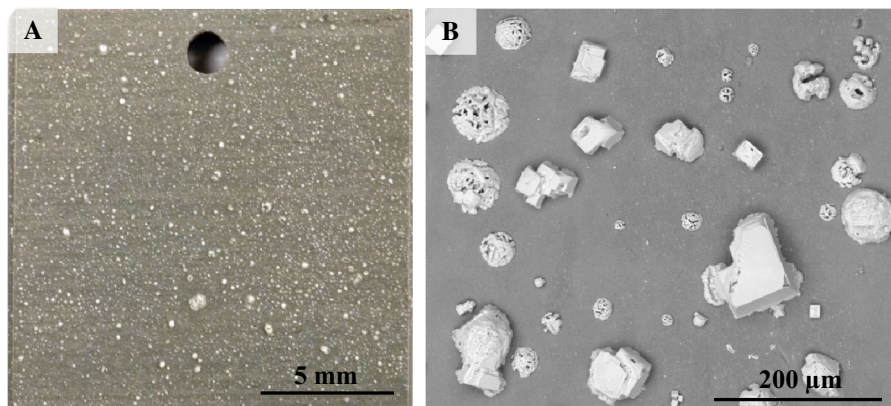
Fig. 2 Optical image (a) and SEM-BSE micrograph (b) of the salt distribution on the alumina scale prior to corrosion exposure

Figure 2 shows the distribution of KCl on the sample surface before exposure, with salt crystallites and aggregates ranging in size from a few μm to $\sim 100 \mu\text{m}$. While the surface between the salt particles appears to be free from KCl, it was shown previously [17, 20] that small amounts of KCl were present also in these areas.

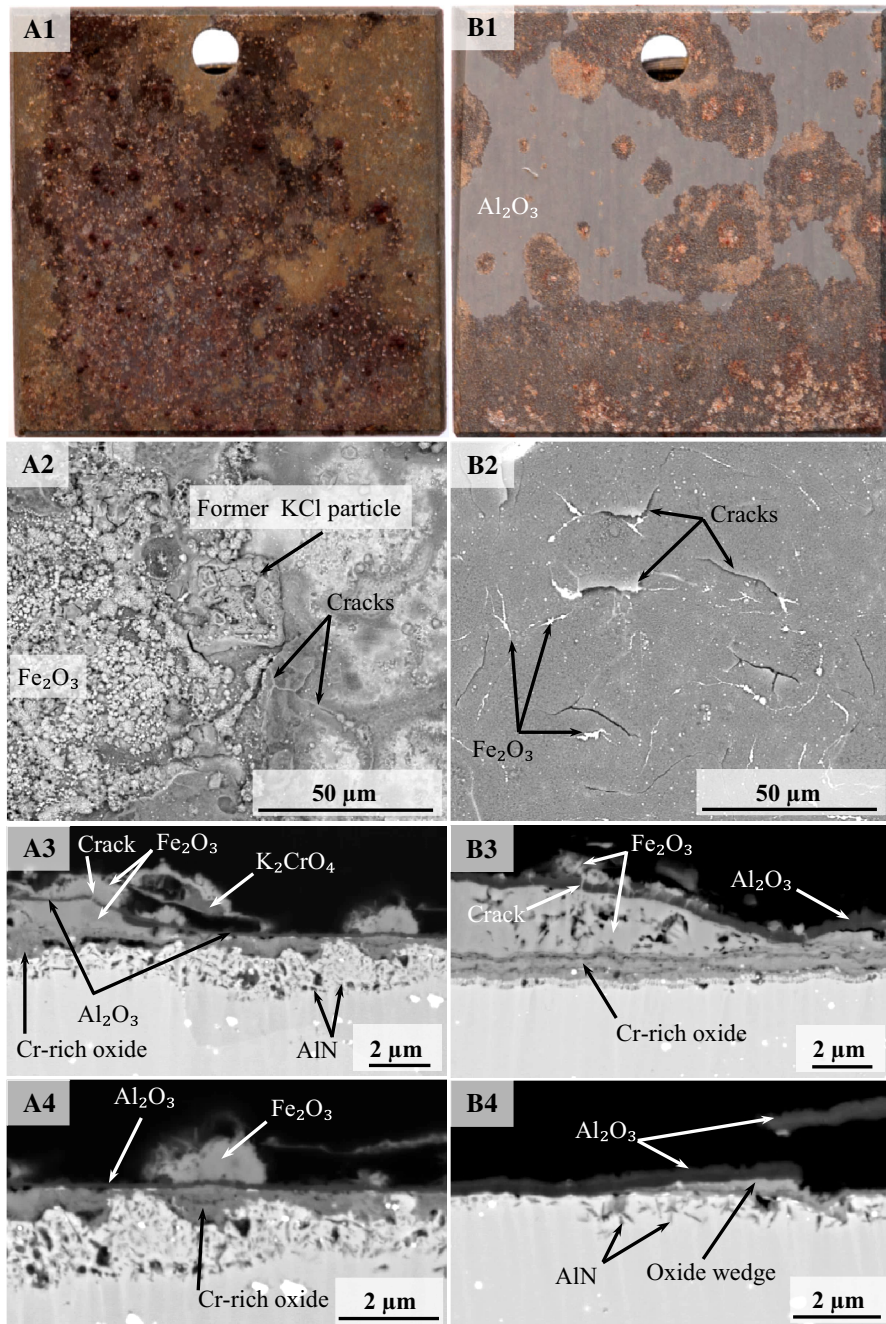
Fig. 3 Optical images and SEM-BSE micrographs of top-view and cross-sections of the pre-oxidized samples **a1–a4** (1 h, 900 °C) to the left and **b1–b4** (1 h, 1,100 °C) to the right exposed for one corrosion exposure ($O_2 + H_2O + N_2 + KCl$ at 600 °C for 24 h)

The alumina scales formed during 1 h pre-oxidation at 900 °C failed during the first corrosion exposure (Fig. 3a1), i.e., the entire surface suffered breakaway oxidation. This is illustrated in the SEM-BSE top view micrograph in Fig. 3a2, which shows a representative area of the corroded surface with a former KCl particle in the middle of the micrograph, surrounded by a cracked alumina scale. During the first corrosion exposure, iron-rich oxide had grown on top of the alumina scale, covering most of the sample surface. Analysis using XRD after the corrosion exposure showed the presence of potassium chromate (K_2CrO_4) and hematite ($\alpha\text{-Fe}_2\text{O}_3$) in addition to $\alpha\text{-Al}_2\text{O}_3$, which was present after pre-oxidation (Table 2). SEM imaging at higher magnification revealed numerous 1–2 μm -size particles on the surface (not distinguishable in Fig. 3a2). Analytical analysis using SEM/EDX confirmed the presence of K, Cr and O and it was concluded that they consisted of K_2CrO_4 .

The one-sided cross-section in Fig. 3a3 and a4 (a4 is an enlargement of a part of a3) shows a layered oxide scale. The alumina layer from the pre-oxidation stage contains several cracks and relatively thick layers of iron-rich oxide have formed in connection to these cracks, both above and below the alumina. The K_2CrO_4 particles detected in the top view can also be seen in the cross section (Fig. 3a3), and are always found on top of the cracked alumina layer, being associated with iron oxide. Below the iron oxide/alumina/iron oxide sandwich a chromium-rich oxide layer is present (Fig. 3a3). Just beneath the chromium-rich oxide layer there is an Oxidation Affected Zone (OAZ) in the alloy substrate containing small needle-like particles. EDX point analyses showed that the particles are enriched in nitrogen and aluminium and their needle-like shape is consistent with aluminium nitride (AlN), which suggests the presence of AlN in the OAZ.

Corrosion of Samples Pre-oxidized 1 h at 1,100 °C Pre-oxidation for 1 h at 1,100 °C also failed to be protective during the first corrosion exposure, with more than half of the sample surface exhibiting breakaway oxidation (Fig. 3b1). The SEM-BSE top view micrograph in Fig. 3b2, shows a relatively lightly corroded area (corresponding to the grey area in Fig. 3b1) consisting of an alumina scale containing several cracks and fissures. SEM/EDX point analysis showed that the bright areas associated with the cracks are dominated by iron oxide. Similar to the samples pre-oxidised at 900 °C for 1 h (see above), K_2CrO_4 particles were detected on the surface using SEM/EDX. In addition to the $\alpha\text{-Al}_2\text{O}_3$ formed during pre-oxidation, XRD analysis detected $\alpha\text{-Fe}_2\text{O}_3$ and potassium chromate (Fig. 4).

The one-sided cross-section in Fig. 3b3 was prepared from an area corresponding to the top view image in Fig. 3b2, which shows a cracked alumina layer with a thickness of about 0.4 μm . In contrast to the previous case (900 °C, 1 h pre-oxidation), the iron-rich oxide is mainly found beneath the alumina layer (compare Fig. 3a3, b3). A chromium-rich oxide is present underneath the iron-rich oxide and there is an OAZ containing needle like aluminium nitride precipitates in the substrate. There is less nitride formation compared to the sample pre-oxidized for 1 h at 900 °C, which indicates that the alumina scale was more protective in this

case (compare Fig. 3a3, b3). The image of the cross-section in Fig. 3b4 shows the early stage of a corrosion attack, at a location where the alumina scale has cracked. A wedge-shaped layer consisting of iron-rich oxide (SEM/EDX) has formed underneath the protective alumina scale, accompanied by nitride formation in the alloy substrate.

After scale failure, the alloy suffered nitridation, especially in the case of the samples pre-oxidized for 1 h (Fig. 3). Once again, the corrosion behaviour was similar to that reported for the same alloy without pre-oxidation [15]. The needle-like nitride precipitates were analysed in detail in [15] and it was concluded that they consisted of AlN. Nitridation of the investigated alloy was not detected in the absence of KCl [17]. Nitridation implies that the oxide scale is permeable to N₂ molecules. It is argued that the corrosion attack connected to the formation of K₂CrO₄ and to alloy chlorination (Reaction (2)) creates pathways/cracks through which N₂ molecules to penetrate the oxide scale. N₂, subsequently, dissociates at the metal surface and dissolves into the alloy. Nitridation is expected to make it more difficult for the alloy to form a new protective external alumina scale because it depletes the alloy substrate in aluminium. It may be noted that in the present study, nitride particles were not observed in the cross sections prepared from regions close to the alumina crack tips (Fig. 7). This is not unexpected in an area where the alumina scale has recently failed, because the processes of N₂ diffusion, dissolution and nitride nucleation are not instantaneous.

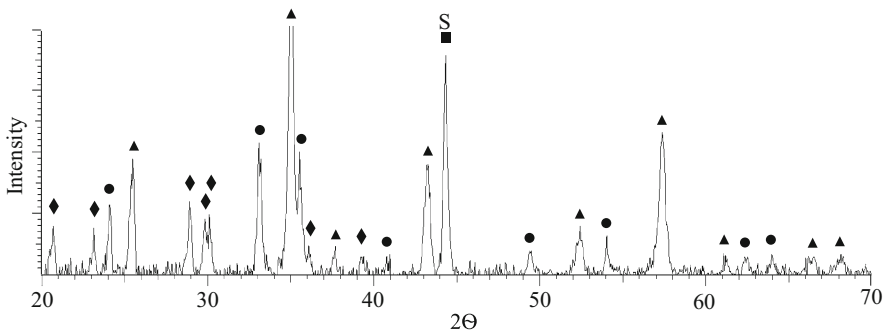
**Fig. 4** XRD diffractogram of pre-oxidized APMT (1 h, 1,100 °C) exposed for one corrosion exposure (O₂ + H₂O + N₂ + KCl at 600 °C for 24 h). The symbols indicate: K₂CrO₄ (filled diamond), α -Fe₂O₃ (filled circle), α -Al₂O₃ (filled triangle), and substrate (filled square)

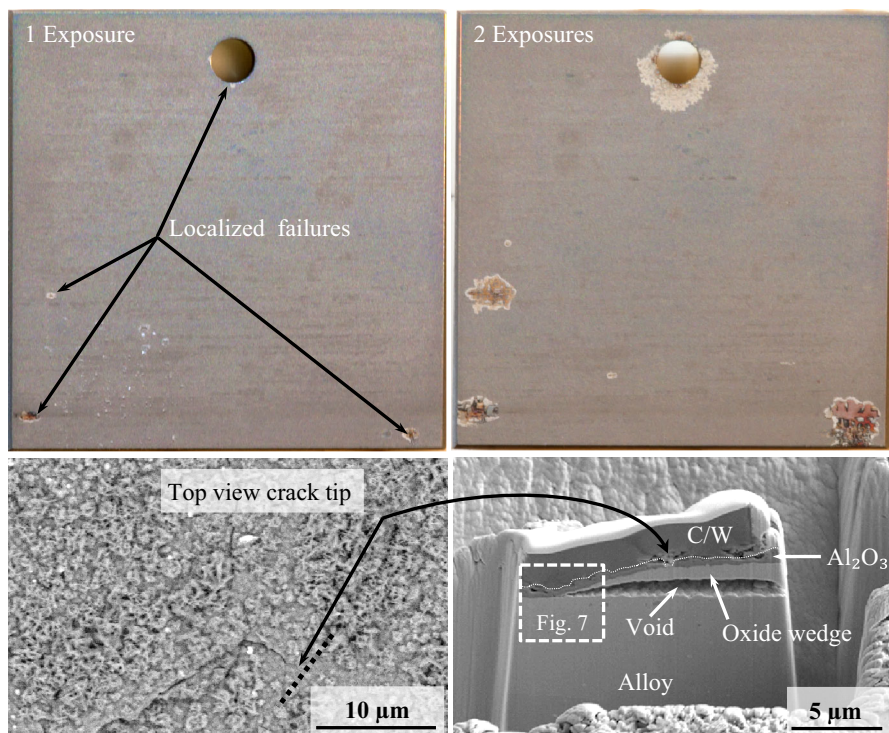
Fig. 5 Optical images of pre-oxidized APMT (24 h, 900 °C) exposed for one and two corrosion exposures ($O_2 + H_2O + N_2 + KCl$ at 600 °C for 24 h). The SEM-BSE top view micrograph (*left*) and SEM-SE image on the right-hand side shows the corrosion front with a visible crack tip after two corrosion exposures

Corrosion of Samples Pre-oxidized 24 h at 900 °C The samples pre-oxidized 24 h at 900 °C were much less corroded after the first corrosion exposure compared to both 1 h pre-oxidations (compare Figs. 5, 3). Nevertheless, the alumina scale had failed at a few locations. The failures were located both on the polished surface (1 μ m diamond suspension) and close to the ground edges (320 SiC paper). The second corrosion exposure resulted in lateral growth of the areas that suffered localised attack during the first corrosion exposure. The areas exhibiting localized corrosion were similar to the ones described above (1 h pre-oxidations). Thus, cracks can be seen in the alumina layer, and are associated with iron-rich oxide and K₂CrO₄ particles (Fig. 6). It can be noted that K₂CrO₄ was also observed at a distance from the cracks in the alumina scale. The presence of α -Fe₂O₃ and K₂CrO₄ was corroborated using XRD (Table 2).

The top view SEM-BSE image of an area at the corrosion front in Fig. 5 (lower left), far away from the iron-rich oxide, shows the end of a crack in the alumina scale. Iron-rich oxide was not detected in imaging from top view. In order to investigate the early stages of alumina scale failure, a TEM specimen was prepared at the crack tip

normal to the direction of the crack (see dotted line). An image of the TEM sample before the final thinning is shown in Fig. 5 (lower right), and reveals a wedge-shaped oxide underneath the alumina layer. SEM/EDX analysis showed that the oxide wedge is iron-rich. Figure 5 shows that the alumina/iron oxide scale is partly detached from the alloy. The point where the alumina scale is detached from the alloy coincides with the tapered end of the iron rich oxide wedge and is considered to correspond to the corrosion front. A comparison of the top view and cross section images in Fig. 5 reveals that the crack tip, seen in top-view, does not coincide with the corrosion front as captured by the cross-section image. Figure 7 shows a STEM micrograph of the corrosion front, complemented by STEM/EDS elemental maps. The analysed TEM foil had a thickness of about 100 nm and carbon and tungsten were deposited for protection of the surface during sample preparation. The interface between the carbon/tungsten deposit and the alumina scale is illustrated with the dotted line in Fig. 5. During final sample thinning, part of the iron-rich oxide wedge was milled away by gallium ions, thus enlarging the void seen in Fig. 5. The void was also affected by re-deposition. Therefore, the STEM/EDS analysis was performed at the far left in the micrograph (boxed area in Fig. 5).

A typical case is shown in Figs. 5, 6 and 7 (24 h pre-oxidation at 900 °C, one and two corrosion cycles). The cracks in the alumina scale are associated with potassium chromate and iron-rich oxide at the scale/gas interface (Fig. 6). Below the alumina, a layered iron-rich oxide had formed as a result of corrosion. It may be noted that the crack in the alumina scale seen in the top-view (Fig. 5 lower left) corresponds to de-cohesion of the alumina/alloy interface (Figs. 5, 7). Significantly, chlorine was detected at the alumina/alloy interface in front of the crack tip, in a region where the Al₂O₃ layer remained seemingly intact and in contact with the alloy substrate (Fig. 7). The same image shows that chlorine penetrated far ahead of potassium, which indicates that transition metal chlorides (FeCl₂ and/or CrCl₂) were present at the alumina/alloy interface. Chlorination with HCl(g) (generated by Reaction (1)) is not considered to be the source of subscale chloride in this case because the HCl generated by Reaction (1) will form at the gas/scale interface and will be transported away from the sample by the flowing gas.

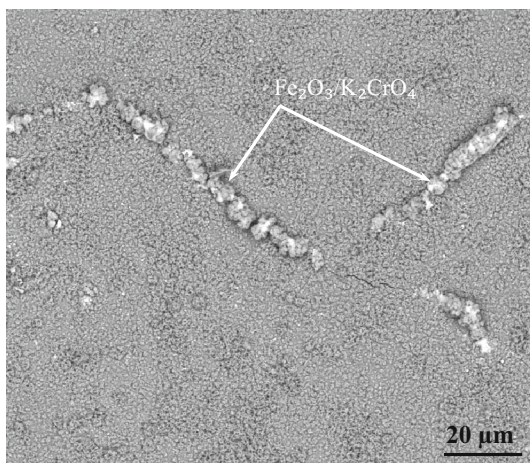
Fig. 6 SEM-BSE micrograph of pre-oxidized APMT (24 h, 900 °C) exposed for two corrosion exposures ($O_2 + H_2O + N_2 + KCl$ at 600 °C for 24 h) showing the cracked alumina scale. Iron oxide and K_2CrO_4 have formed in the cracks

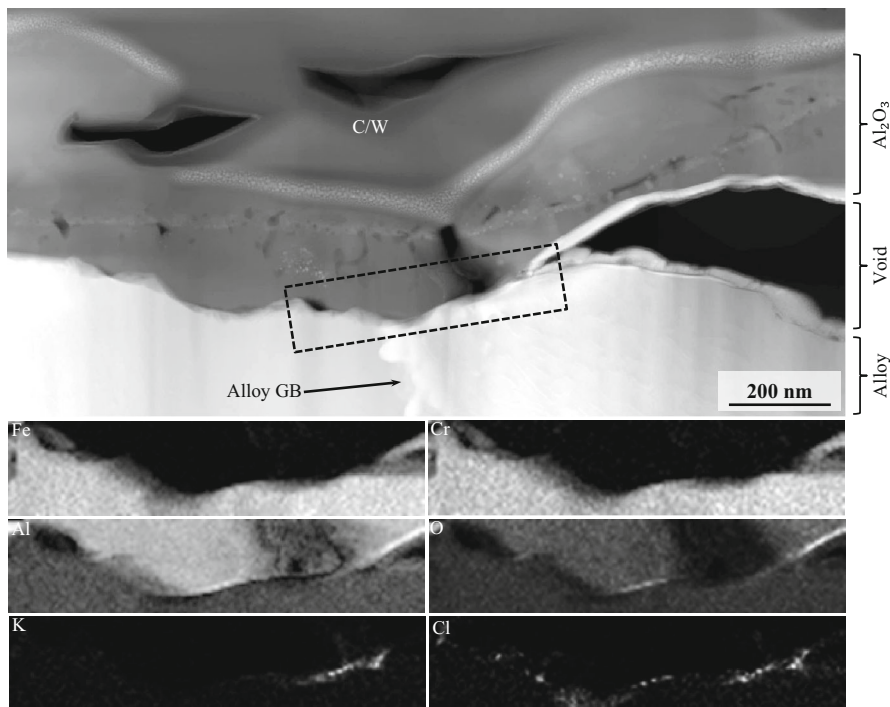
Fig. 7 Elemental maps of the boxed area in the STEM-HAADF micrograph of pre-oxidized APMT (24 h, 900 °C), exposed two corrosion exposures ($O_2 + H_2O + N_2 + KCl$ at 600 °C for 24 h)

Figure 7 depicts a High Angle Annular Dark Field (HAADF)-STEM micrograph of the area where the alumina scale detached from the alloy substrate

(corresponding to the corrosion front). To the left of the corrosion front, the alumina scale is well adhered to the alloy substrate, i.e., no porosity was detected in the alumina/alloy interface. The boxed area in Fig. 7 was subjected to STEM/EDS mapping. The corresponding elemental maps for iron and chromium indicate that a Fe, Cr oxide is present just to the right of the corrosion front, to the far right in the boxed area. This corresponds to the remains of the iron-rich oxide wedge in Fig. 5. Gallium was detected together with the Fe,Cr oxide to the far right in the boxed area, showing that this area had been affected by sample preparation. The remaining part of the boxed area was not affected by the re-deposition. Potassium was enriched in the interface between the alumina scale and alloy close to the corrosion front while chlorine was detected throughout the whole alumina/alloy interface (Fig. 7). In addition STEM/EDS analyses (not shown) showed that the alloy grain boundary in Fig. 7 was enriched in Mo while the alloy grains were depleted in Mo. It should be noted that Mo is homogeneously dispersed in the alloy matrix in the as-delivered

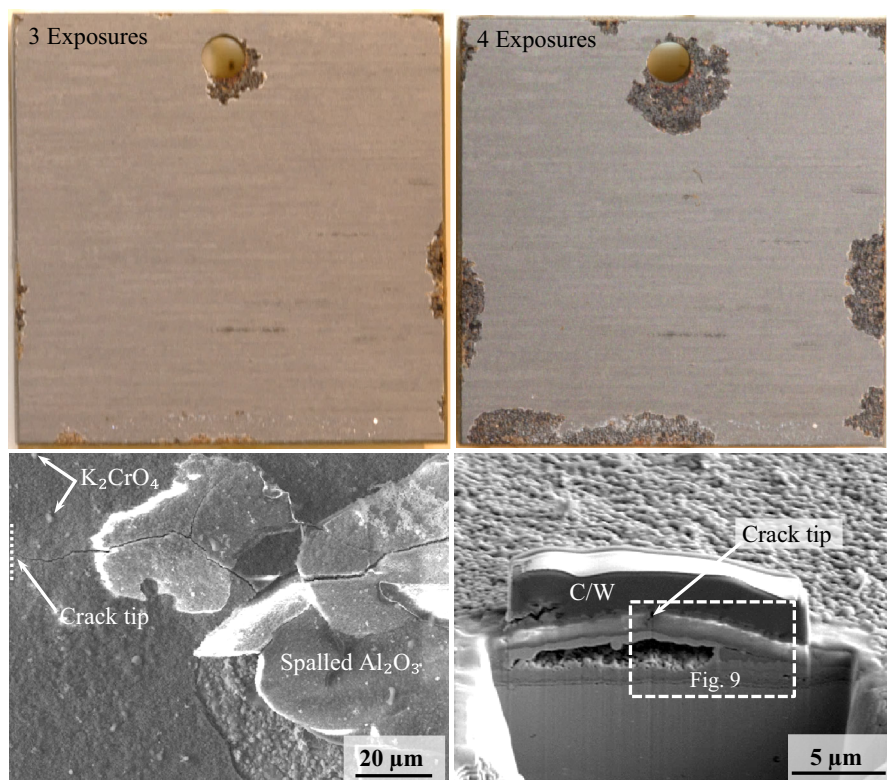
Fig. 8 Optical images of pre-oxidized APMT (24 h, 1,100 °C) exposed for three and four corrosion exposures ($O_2 + H_2O + N_2 + KCl$ at 600 °C for 24 h). The SEM-SE top-view micrograph (lower left, four corrosion exposures) of the periphery of a corroded area shows the cracked and partly spalled alumina layer. The cross section was obtained at a crack tip in the alumina layer as indicated by the dotted line

A TEM specimen was prepared from the area at a crack tip, see dotted line in Fig. 8 (top view image, lower left). Figure 8 shows an image of the TEM sample before thinning (lower right), in which the cracked alumina layer with a thick oxide scale can be seen underneath. The STEM micrograph in Fig. 9 was complemented by the STEM/EDS line scan from A to B and by point analyses.

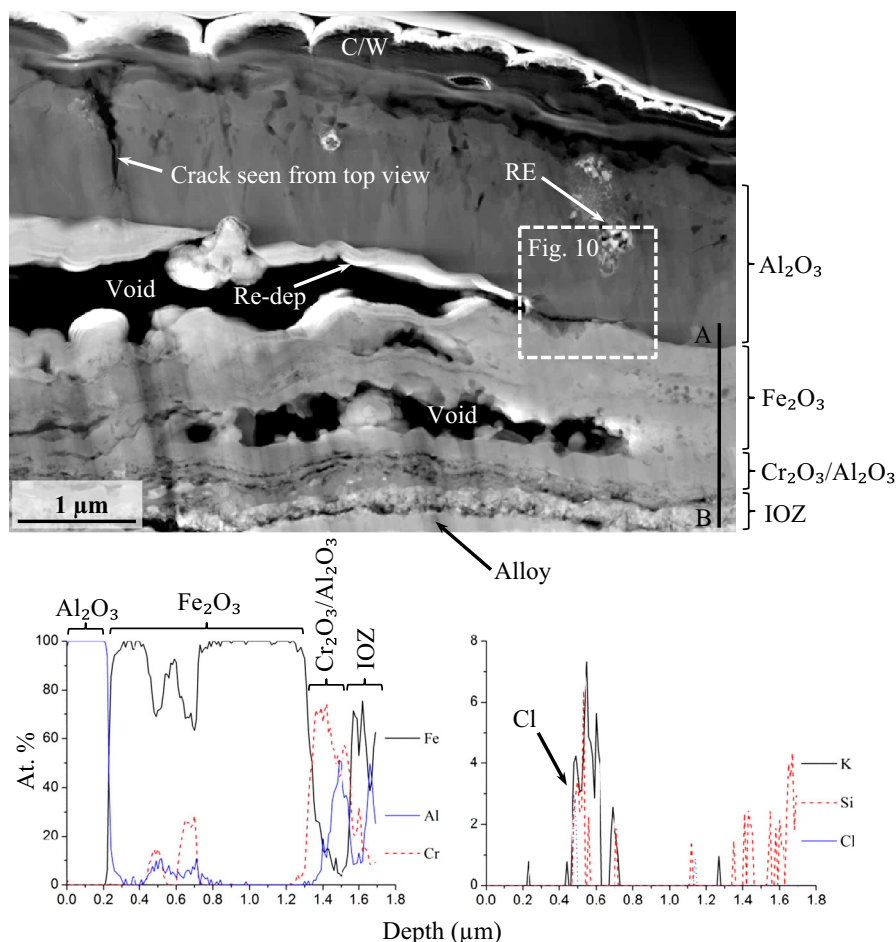
Fig. 9 STEM-HAADF micrograph of pre-oxidized APMT for (24 h, 1,100 °C), after four consecutive corrosion exposures ($\text{O}_2 + \text{H}_2\text{O} + \text{N}_2 + \text{KCl}$ at 600 °C for 24 h). The micrograph shows the area at the crack tip in Fig. 8. The EDS line profile from A to B probes the bottom part of the original alumina scale, the oxide underneath it and the corresponding IOZ

The STEM-HAADF image of the cross-section in Fig. 9 reveals that the crack seen in the top view image (Fig. 8) does not reach all the way through the alumina scale. It may be noted that is difficult to prepare a TEM foil specimen exactly at the crack tip because the TEM foil is only about 100 nm thick. The crack is believed to run through the entire alumina layer at some location close to the region represented by the obtained TEM foil. The area sampled by the TEM foil shows a relatively advanced stage of corrosion attack, with a rather thick ($\sim 1.5 \mu m$) oxide present underneath the alumina layer. It can be seen that the oxide scale is partly cracked and contains several large voids. At the bottom of the scale an Internal Oxidation Zone (IOZ) seems present (see below).

In the vicinity of the voids on the left-hand side in Fig. 9, there are signs of redeposition from sample preparation (mostly Ga). Consequently, the EDS analysis was conducted on the right-hand side of the micrograph. The RE particle indicated in the alumina layer contained low amounts of Ta and Zr together with alumina. The EDS line-scan (A to B in the micrograph) probed the bottom part of the alumina layer, the oxide underneath it and the OAZ in the alloy. The top 4/5 of the oxide below the alumina layer was dominated by iron oxide but also exhibited Al- and Cr-rich bands containing small amounts of K, Si and Cl. Below the iron oxide there was a ~ 200 nm thick layer which consisted of chromia and alumina, and where the alumina component was closest to the alloy. The XRD (Table 2; Fig. 4) analyses did not result in any diffraction from Cr_2O_3 and it is believed to be due to the

relative thin layers that are present in the scale. EDS point analysis indicated that the area immediately below the chromia/alumina layer had been partly oxidized. This ~ 200 nm thick layer is interpreted as an IOZ.

The STEM/EDS line profile in Fig. 9 shows that the oxide underneath the failed alumina layer essentially consisted of iron oxide, most likely hematite. In the middle of this layer, the iron oxide was mixed with considerable amounts of chromium and aluminium oxide together with small amounts of chlorine, potassium and silicon. It is argued that this region corresponds to the alloy immediately below the scale/alloy interface, before the failure of the alumina scale. This implies that the iron oxide layer had grown both outward and inward. Below the iron-rich oxide is a layer of relatively pure chromia. The lower part of this chromia layer, at the new scale/alloy interface, is enriched in alumina. It may be noted that the oxide underneath the failed alumina scale is very similar to the scale formed when the same alloy has been exposed to this environment without pre-oxidation [15].

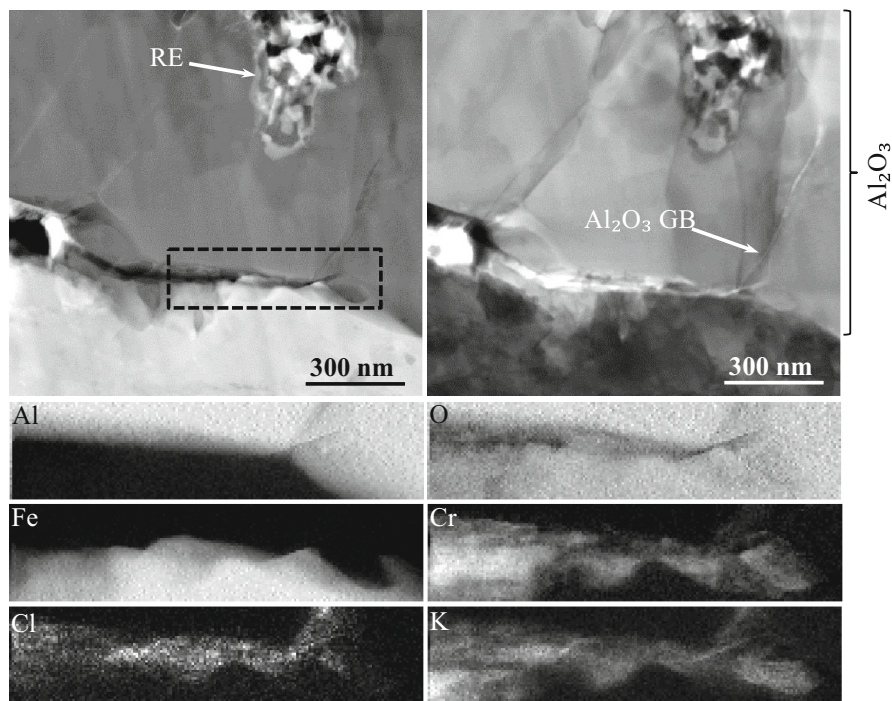
Fig. 10 EDS Elemental maps of the boxed area in the STEM-HAADF micrograph in Fig. 9 of pre-oxidized APMT (24 h, 1,100 °C), exposed two corrosion exposures ($O_2 + H_2O + N_2 + KCl$ at 600 °C for 24 h). A alumina grain boundary is indicated in the STEM-BF image

The lateral crack between the alumina and the iron-rich oxide layer (boxed area in Fig. 9) was investigated further with STEM/EDS elemental mapping (Fig. 10). The analysis showed that the crack was enriched in Cr, K and Cl. It may be noted that potassium and chlorine (corresponding to KCl) were also present in a grain boundary in the alumina layer (to the right in Fig. 10).

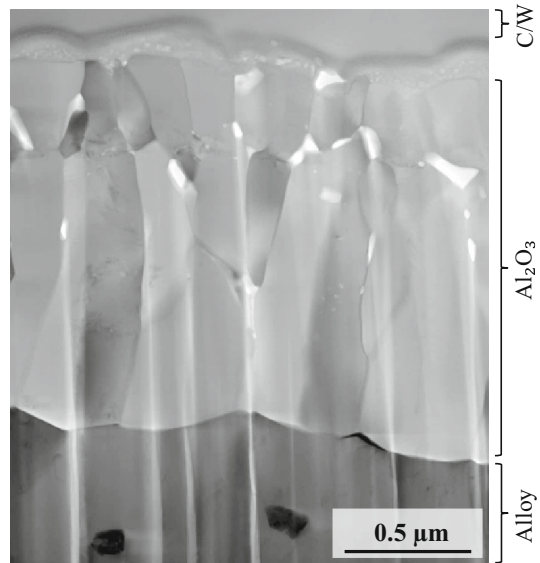
Fig. 11 STEM-BF micrograph of pre-oxidized APMT (24 h, 1,100 °C), exposed four corrosion exposures ($\text{O}_2 + \text{H}_2\text{O} + \text{N}_2 + \text{KCl}$ at 600 °C for 24 h). The TEM specimen was obtained far away from the corrosion front

top-view imaging revealed no cracks in the alumina scale. Figure 11 shows a STEM-BF image of the cross-section with an adherent alumina layer. No corrosive species e.g. Cl or K were detected using EDS point analyses and elemental mapping (not shown) either in the alumina scale/alloy interface or in the oxide grain boundaries. On top of the alumina scale there was a layer consisting of K, Si, O and Al. Because no crystalline corrosion products were found other than alumina, this layer is suggested to consist of potassium aluminium silicate glass. Previously, crystalline $KAlSiO_4$ was identified on Kanthal® APMT after pre-oxidizing at 700 °C for 24 h in O_2 and then exposed to an $O_2 + H_2O$ environment in the presence of KCl at 600 °C [17].

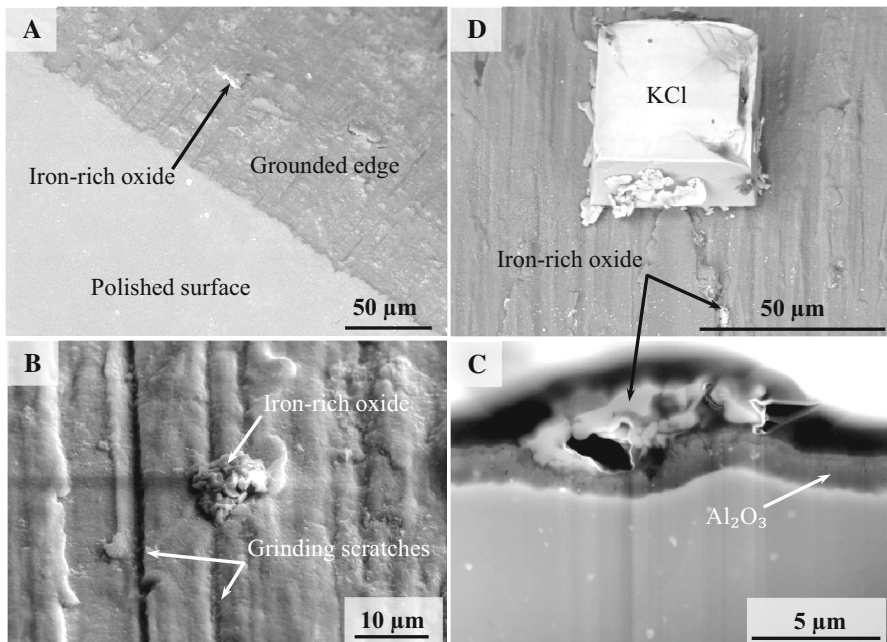
Fig. 12 SEM-BSE images (a, d) and SEM-SE (b, c) of top view and cross section of one grounded edge (320 SiC paper) of pre-oxidized APMT (24 h, 1,100 °C) showing iron-rich oxide nodules. d shows an image of the pre-oxidized edge with added KCl before exposure

The observation that the KCl-induced corrosion of the pre-oxidized samples always began at the sample edges prompted an investigation of the alumina scale formed by pre-oxidation for 24 h at 1,100 °C. While SEM/EDX top-view imaging of the polished surface showed a very smooth alumina scale, the ground sample edges revealed small ($\sim 5\text{--}10\text{ }\mu\text{m}$ in size) iron-rich oxide nodules (Fig. 12a). It was estimated that about 200 of these iron-rich oxide nodules were present at the sample edges after pre-oxidation. Figure 12b and c shows top-view and cross-section SEM images of one of the iron-rich oxide nodules. The top-view image shows the scratches from grinding. The cross-section shows that a continuous alumina layer

was present underneath the iron-rich oxide although it was thinner than the alumina layer formed next to the nodule. Figure 12d illustrates the situation at the edge of a sample before the corrosion exposure, showing a KCl particle in the vicinity of an iron-rich oxide nodule. KCl was also detected on top of some of the iron-rich protrusions before exposure.

absent on the polished surface (Fig. 12). In the cross section of an iron-rich nodule shown in Fig. 12c, the iron oxide is separated from the alloy by an alumina layer which is significantly thinner than the alumina scale in general. It can be speculated that the alumina scale had been damaged at the oxide nodules and that the corrosion started there which would explain the tendency for corrosion to start at the edges. With the information at hand, the initiation of alumina scale failure and corrosion in the presence of KCl may be explained by either cracks caused by thermal mismatch stresses or by the iron oxide nodules at the edges.

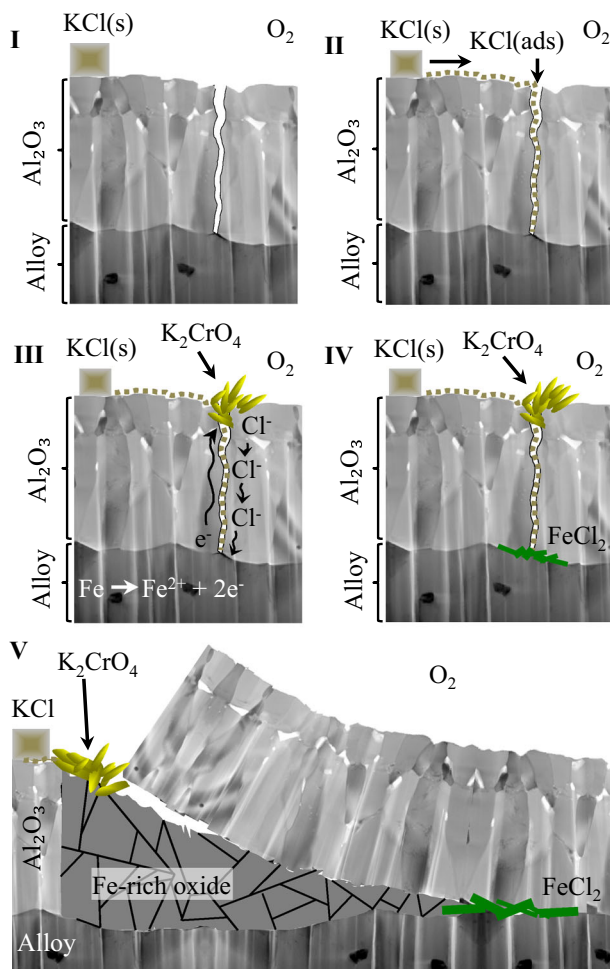
Fig. 13 Schematic illustration of the initiation of the corrosion attack coupled to Reaction (2)

According to observations, the products of Reaction (2) accumulate at the scale/gas interface (K_2CrO_4) and at the scale/alloy interface (FeCl_2) (see Figs. 3a3, 6, and 7). It is argued that, although all the reactants are present at their respective positions, Reaction (2) cannot run if the α -alumina scale is intact because the alumina scale constitutes an effective barrier to the diffusion of ions (Fe^{2+} , Cl^{-}). Once the scale cracks, the situation is fundamentally changed. It is proposed that, when a crack forms during the exposure, KCl immediately enters it by means of surface diffusion, forming an adsorbed layer on the freshly exposed alumina in the crack. This is illustrated in Fig. 13, steps I and II. This is supported by the observation of KCl in a newly formed crack, close to the scale/alloy interface after exposure (Fig. 7). It is proposed that KCl in the crack provides the medium for the ionic current i.e., transport of chloride ions, which is necessary for Reaction (2) to run. Moreover, it is proposed that the corresponding electronic current is carried by alumina (Fig. 13, step III).

Thus, in the presence of a KCl “salt bridge” across the scale, the anodic formation of FeCl_2 at the scale/alloy interface becomes coupled to the formation of potassium chromate at the scale/gas interface (step IV in Fig. 13). Close to the scale/alloy interface, the anodic formation of FeCl_2 (Reaction (2), Fig. 7) causes charged chloride ion vacancies to form in the adsorbed KCl. Simultaneously, at the scale/gas interface, the cathodic reaction consumes K^{+} ions, thus generating an excess of chloride ions in KCl.
